INDOOR AIR QUALITY ASSESSMENT

**East Brookfield Elementary School
410 East Main Street
East Brookfield, Massachusetts**

Prepared by:
Massachusetts Department of Public Health
Center for Environmental Health
Bureau of Environmental Health Assessment
Emergency Response/Indoor Air Quality Program
December 2004

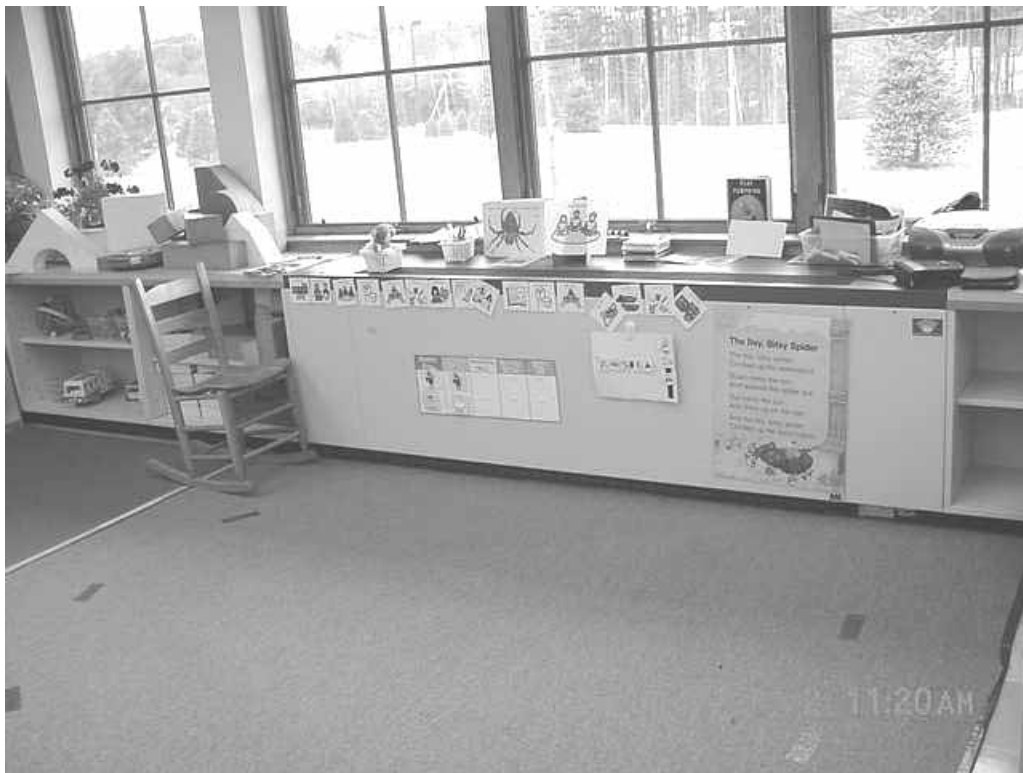
Picture 1

Classroom Univent

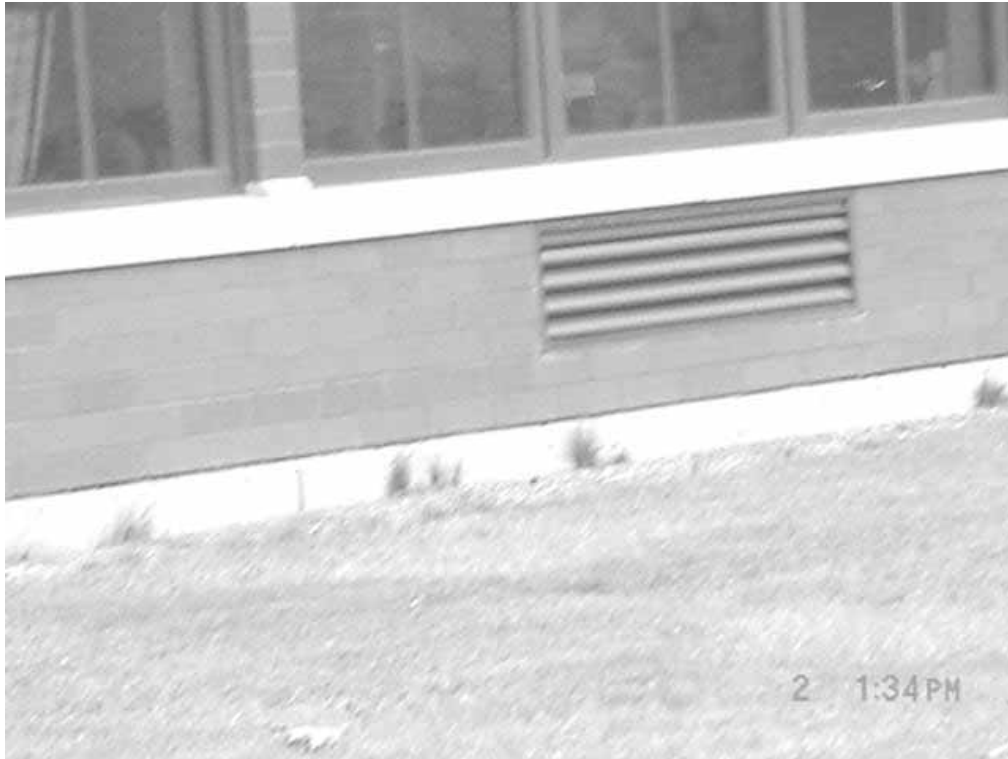
Picture 2

Univent Fresh Air Intake

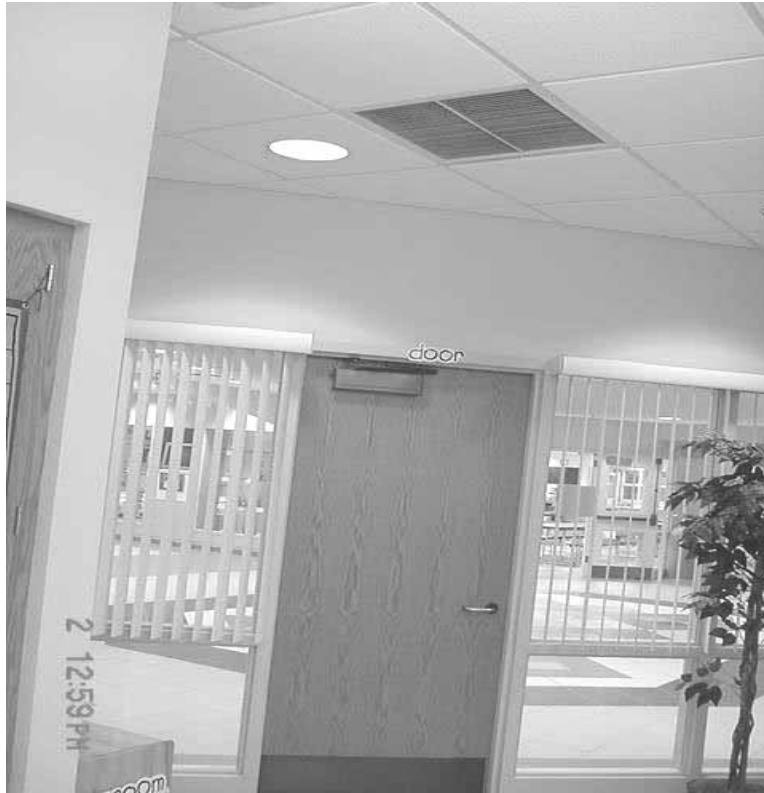
Picture 3

exhaust efficiency. In several areas exhaust vents are located above hallway doors (Picture 3). When classroom doors are open, exhaust vents will tend to draw air from both the hallway and the classroom reducing the effectiveness of the exhaust vent to remove common environmental pollutants.

Ceiling-Mounted Exhaust Vent, Note Proximity to Hallway Door

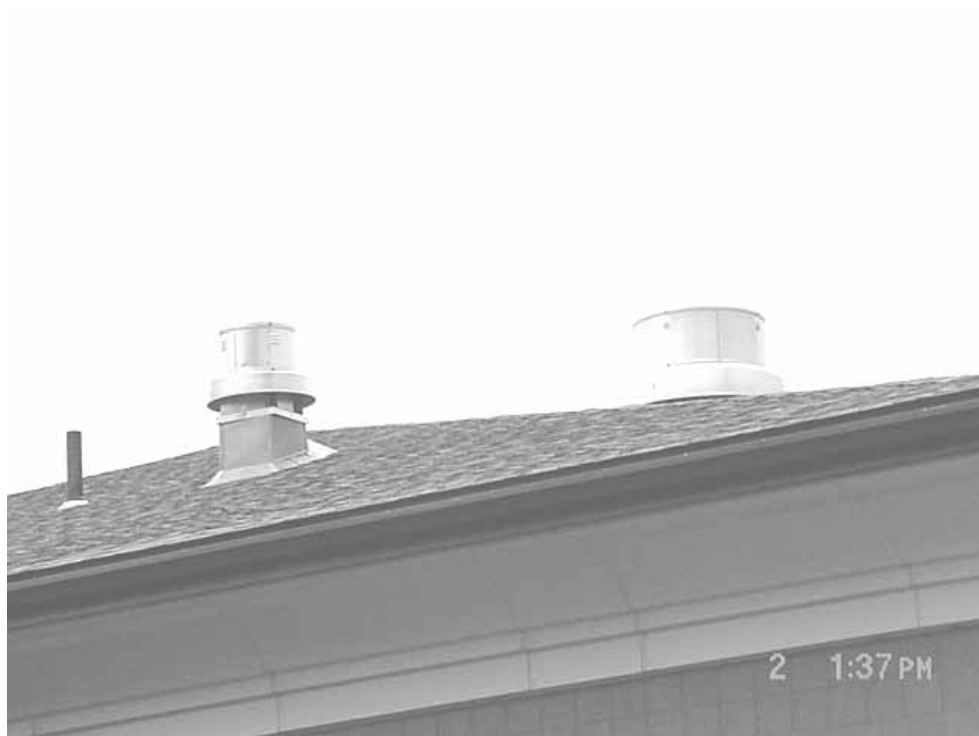
Picture 4

Rooftop Exhaust Motors

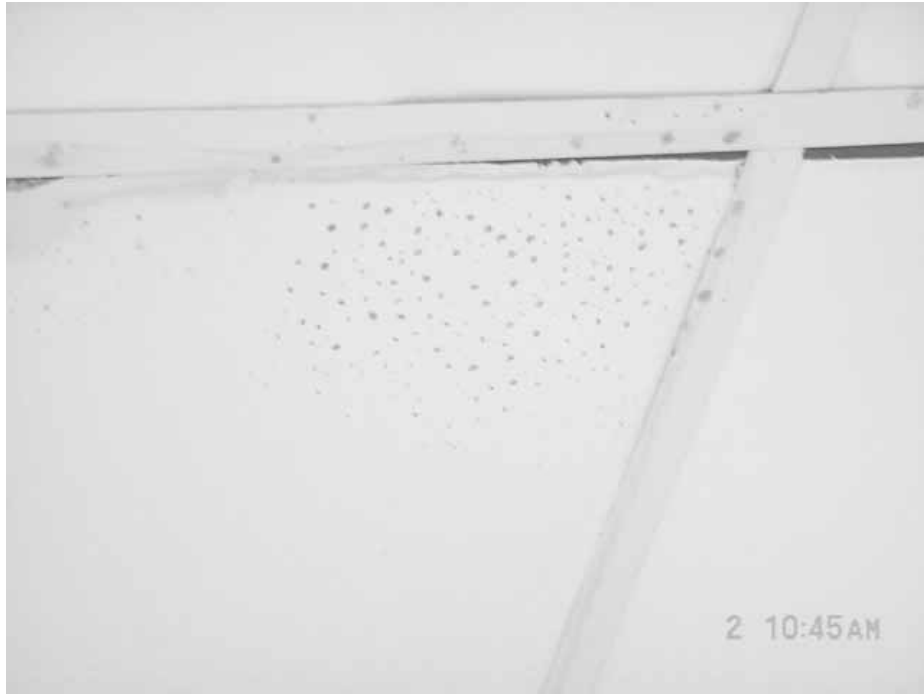
Picture 5

Several areas had water-damaged ceiling tiles, which can indicate leaks from the roof or plumbing system (Pictures 5 and 6/Table 1). Water-damaged ceiling tiles can provide a source of mold and should be replaced after a water leak is discovered and repaired. The majority of stained ceiling tiles observed were located below elbows and joints for the sprinkler system that had slow dripping leaks (Pictures 7 and 8). Repeated water damage to porous building materials (e.g., wallboard, ceiling tiles, carpet) can result in microbial growth. Mold-colonized GW was observed near the base of the wall in the boiler room and on a bathroom ceiling tile in classroom 113.

Water Damaged Ceiling Tile in Kitchen Area near Sprinkler Release

3. Contact a fire prevention firm or plumbing contractor specializing in sprinkler systems to isolate and repair water leaks building-wide. Repair/replace any water-damaged ceiling tiles, plaster and/or other damaged building materials. Examine above and around these areas for mold growth. Disinfect areas of water leaks with an appropriate antimicrobial. Building occupants should report any roof leaks or other signs of water penetration to school maintenance staff for prompt remediation.

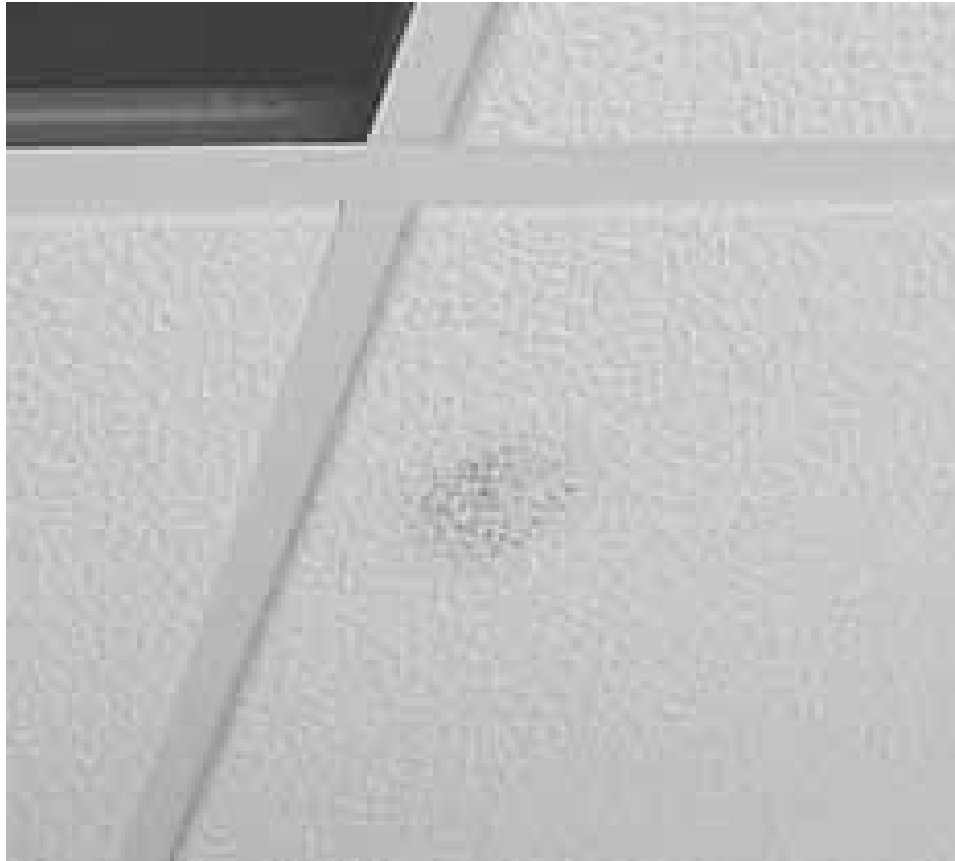
Picture 6

Water Damaged Ceiling Tile, Dark Stain Indicates Possible Mold Growth

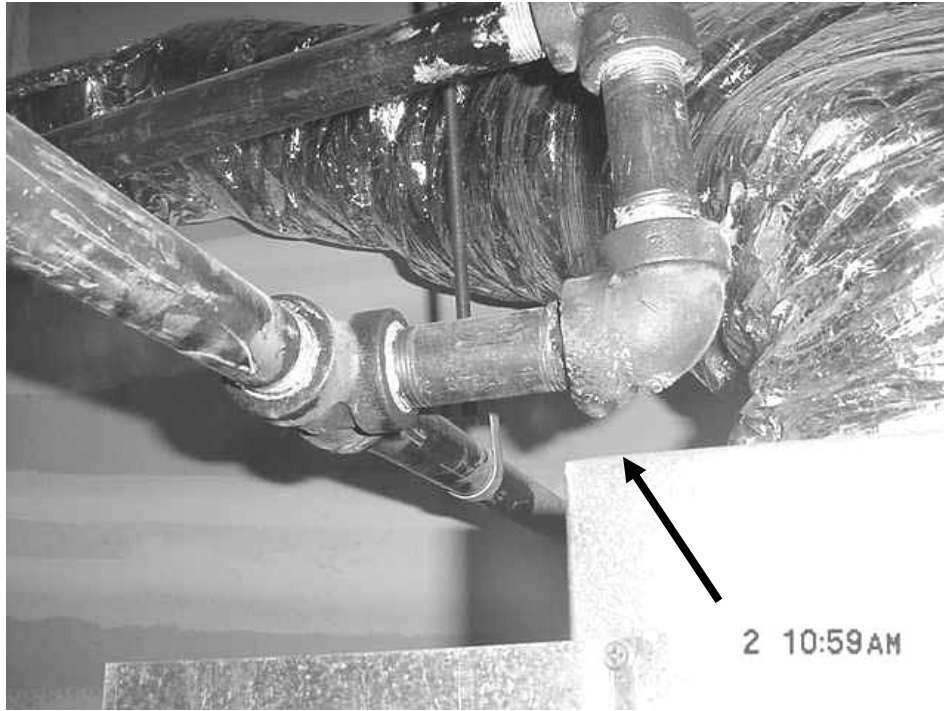
Picture 7

Slow-Dripping Sprinkler Pipe Joint above Ceiling Tile System in Kitchen Area near Restroom

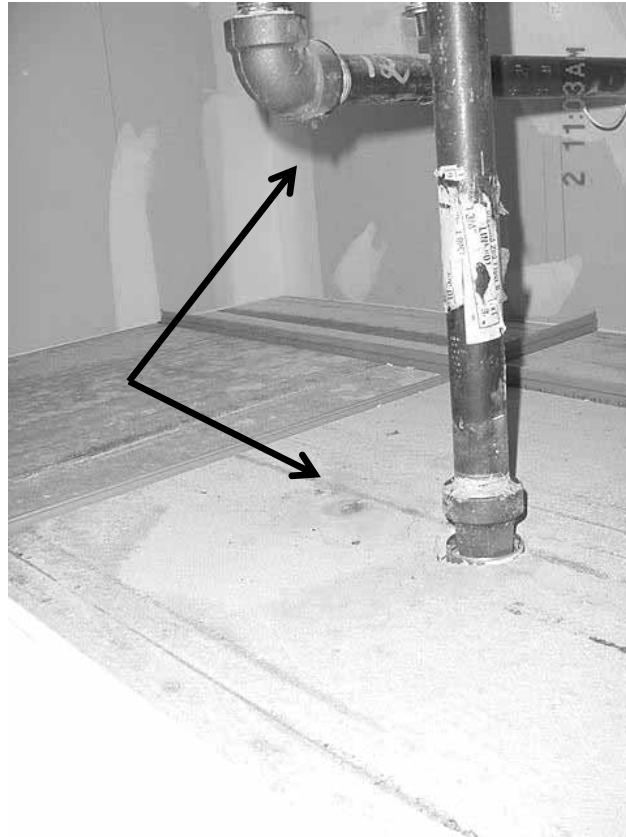
Picture 8

Dripping Sprinkler Joint above Water Damaged Ceiling Tile

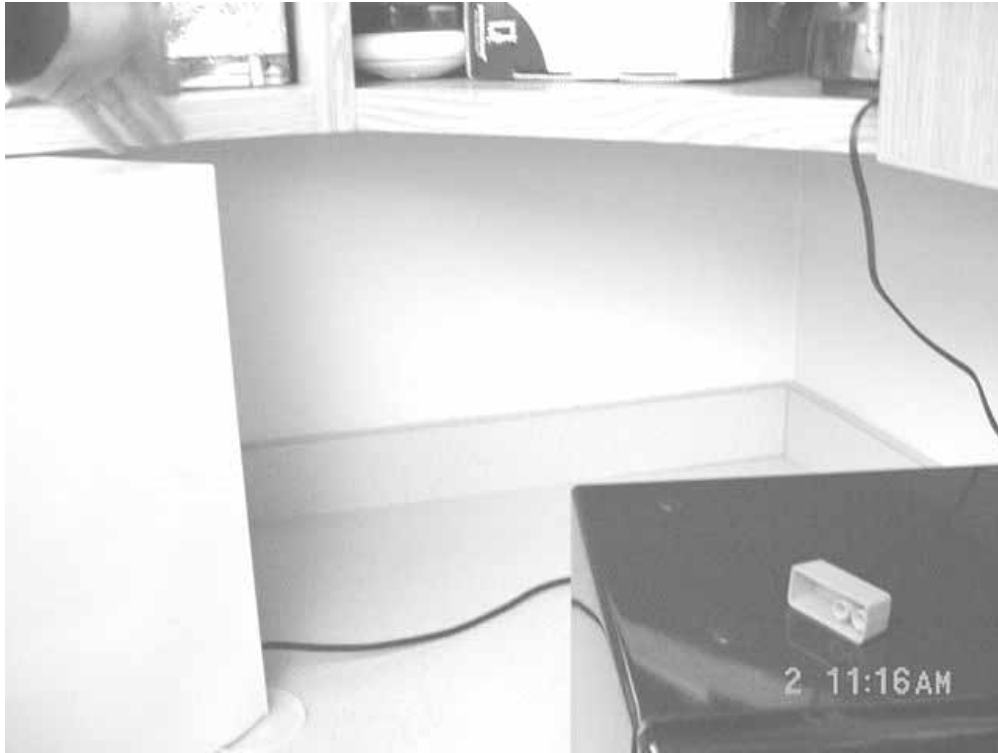
Picture 9

Corner of Classroom 115 Where Elevated Moisture Readings were Taken

4. Remove a small section of GW in classroom 115 to give maintenance personnel the opportunity to observe conditions within the wall cavity and to determine if a chronic source of moisture exists in the wall cavity.

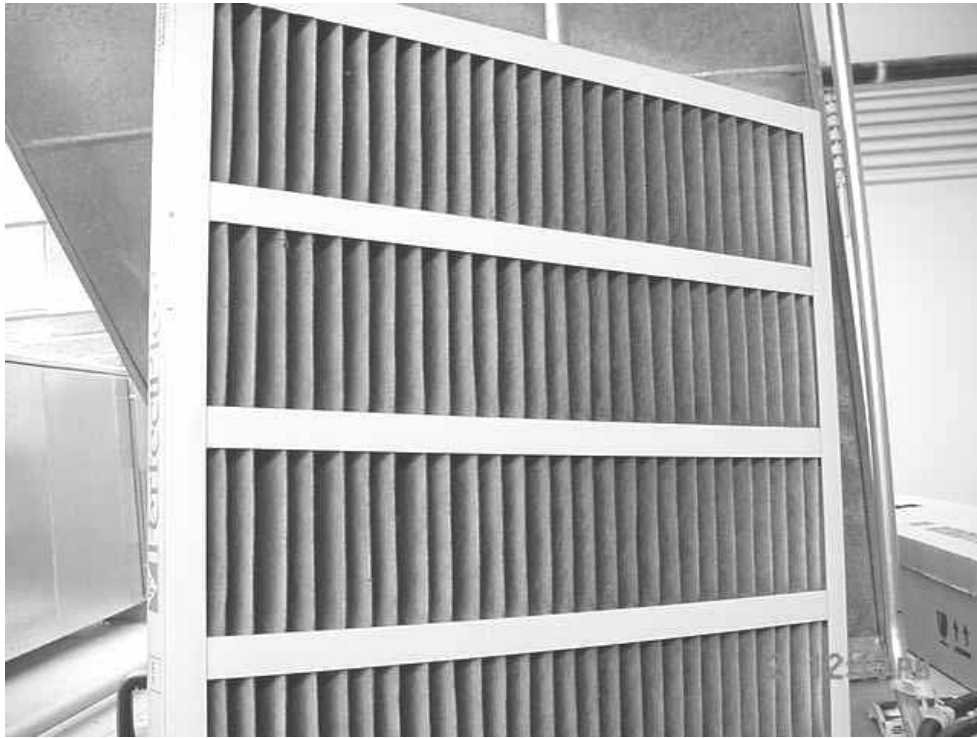
Picture 10

Several other conditions that can affect indoor air quality were observed during the assessment. BEHA staff inspected AHU filters in the mechanical room and found the filters coated with dirt/dust and accumulated material (Pictures 13 and 14). A debris-saturated filter can obstruct airflow and may serve as a reservoir of particulates that can be re-aerosolized and distributed to occupied areas via the ventilation system. In addition, a number of exhaust and return vents had accumulated dust. If exhaust vents are not functioning, backdrafting can occur, which can re-aerosolize dust particles leading to eye, and respiratory irritation.

AHU Filter Occluded with Dust and Debris in Mechanical Room

14. Change filters for AHUs and unit ventilators as per manufacturer's instructions or more frequently if needed.
15. Relocate or consider reducing the amount of materials stored in classrooms to allow for more thorough cleaning. Clean items regularly with a wet cloth or sponge to prevent excessive dust build-up.
16. Clean exhaust/return vents periodically to prevent excessive dust build-up.
17. Consider adopting the US EPA (2000b) document, "Tools for Schools", to maintain a good indoor air quality environment in the building. This document can be downloaded from the Internet at: <http://www.epa.gov/iaq/schools/index.html>.
18. Refer to resource manuals and other related indoor air quality documents for further building-wide evaluations and advice on maintaining public buildings. These materials are located on the MDPH's website at <http://www.state.ma.us/dph/beha/iaq/iaqhome.htm>.

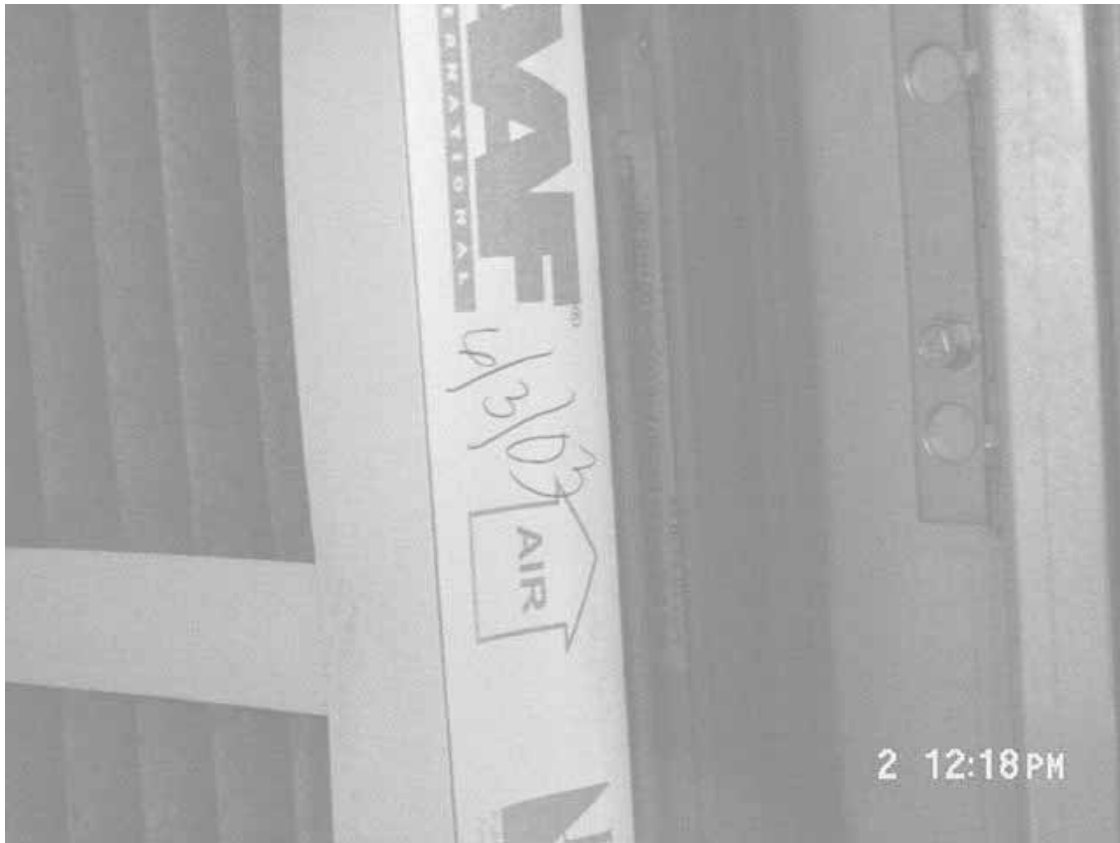
Picture 11

Filter in AHU dated June 3, 2003

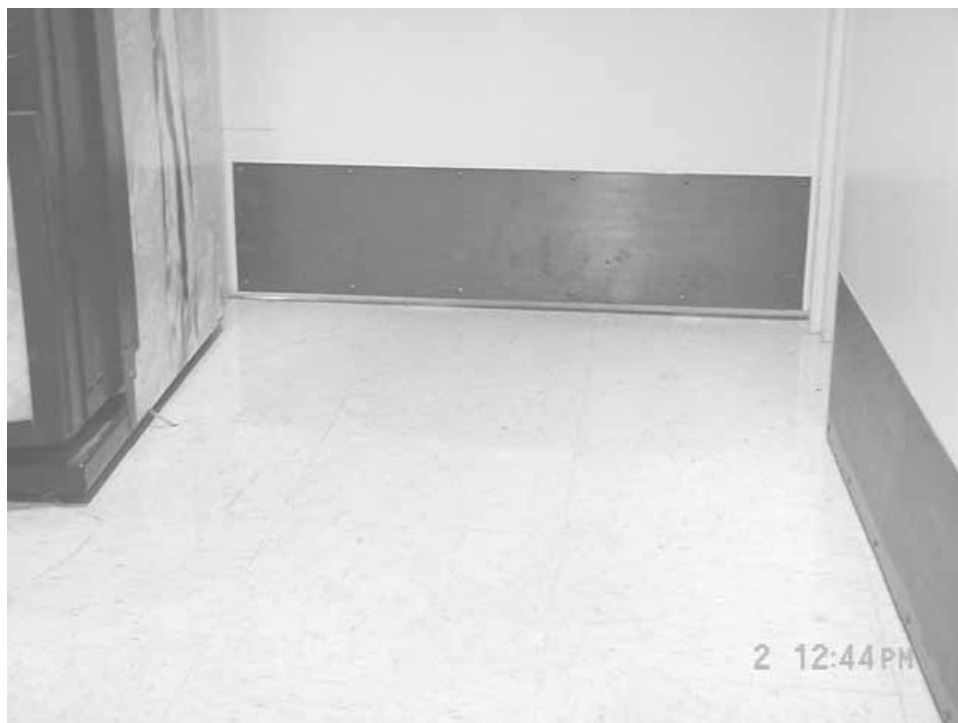
Picture 12

Outdoor concentrations of UFPs were measured at 5.6 to 9 p/cc^3 . The UFP level measured in the boiler room was measured at 3.1 p/cc^3 (Table 1), which was below background. However, spaces were observed around the boiler room door, where light from the room was evident (Picture 11). These spaces can serve as a means of egress for odors, fumes, dusts and vapors from the boiler room into adjacent areas. It also appeared that the actuator bar to the intake louvers to the boiler make-up air vent was disconnected and a stick was temporarily lodged in its place to hold them open (Picture 12).

Space beneath Boiler Room Door

2. Install a door sweep and/or weather-stripping around boiler room door to prevent the potential egress of odors and particulates into adjacent areas.

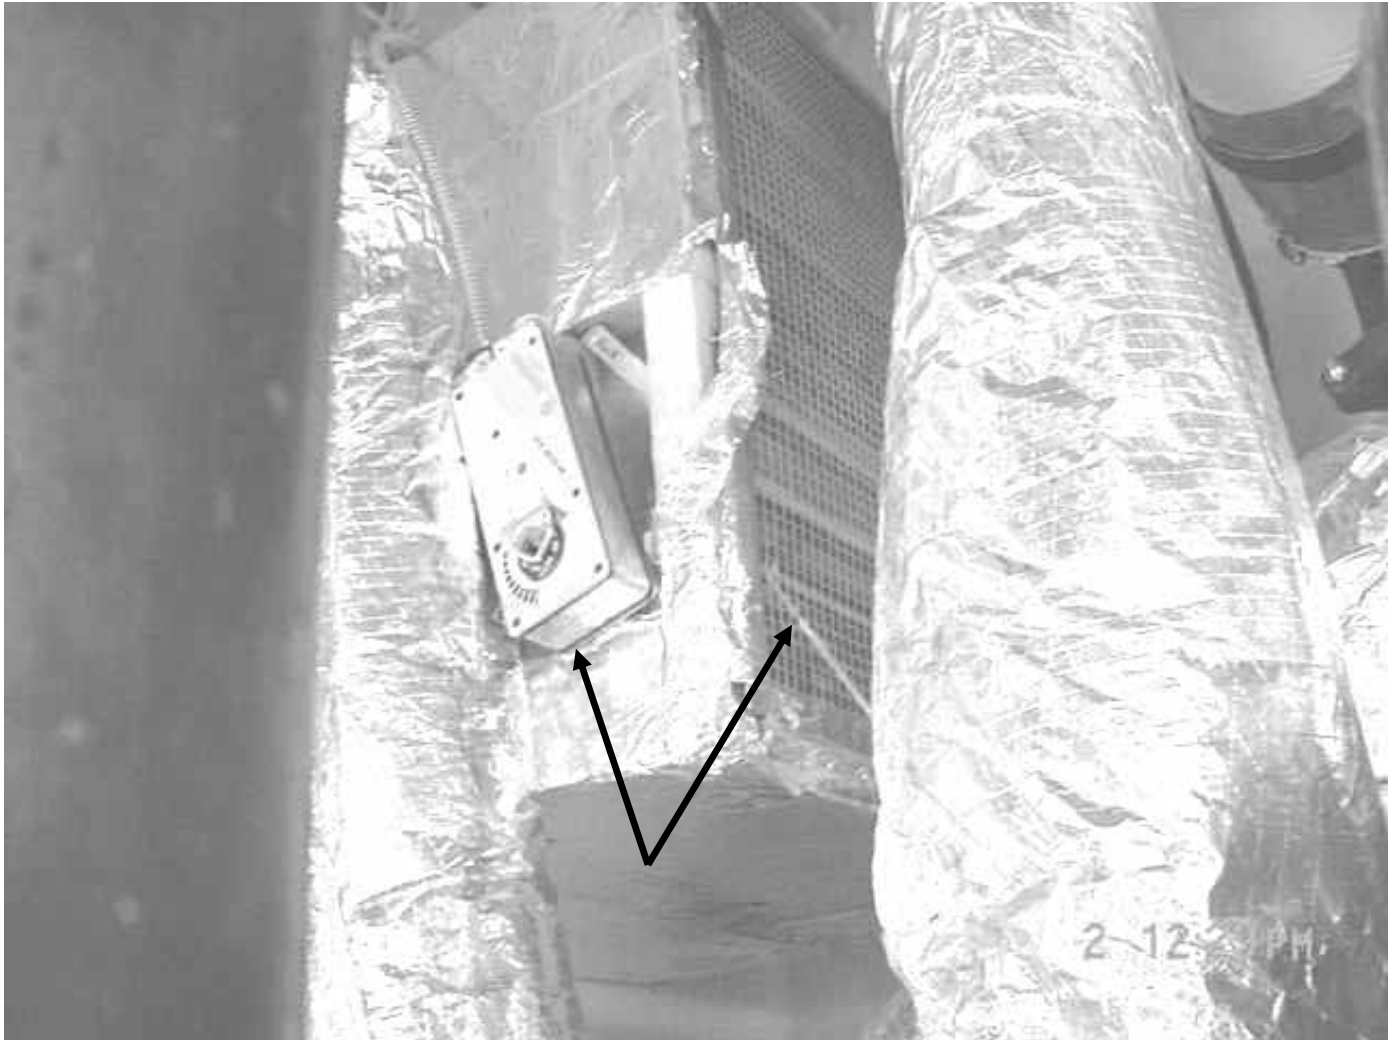
Picture 13

**Disconnected Actuator Control to Make up Air Vent to Boiler Room,
Note Piece of Wood to Hold Louvers Open**

1. Continue working with energy consultants/vendors to make adjustments/repairs to the boiler/venting system and in particular the make-up air vent shown in Picture 12.
